AD NUMBER	
AD357977	
CLASSIFICATION CHANGES	
TO:	UNCLASSIFIED
FROM:	SECRET
LIMITATION CHANGES	
TO: Approved for public release; distribution is unlimited. Document partially illegible.	
FROM: Distribution authorized to U.S. Gov't. agencies only; Administrative/Operational Use; 1953. Other requests shall be referred to Atomic Energy Commission, Washington, DC. Document partially illegible.	
AUTHORITY	
AEC ltr 16 Jun 1980 ; AEC ltr 16 Jun 1980

The purpose of Signal Corps participation in Project 3.20 was to determine the amounts of thermal flux (cal) and peak overpressure (psi) required to cause severe, moderate, light, and negligible damage to selected signal communications-electronics items of equipment and material for which inadequate or no data existed. Knowing these factors it is believed that responsible signal officers can better plan their tactical communications systems and take passive protective measures to reduce damage and losses to acceptable minimums. These data will also be used to improve design of equipment and material.

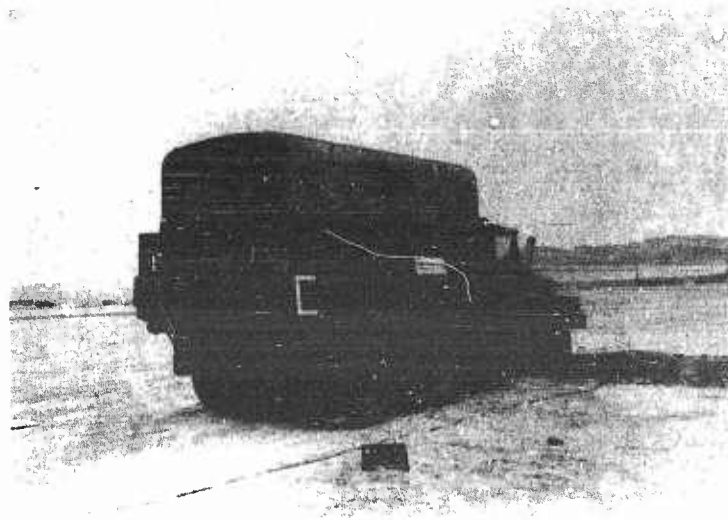
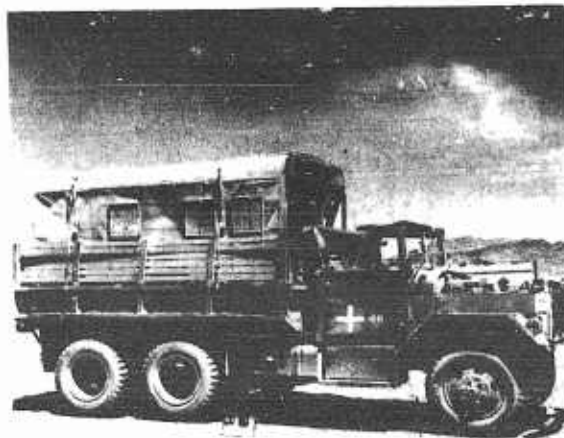
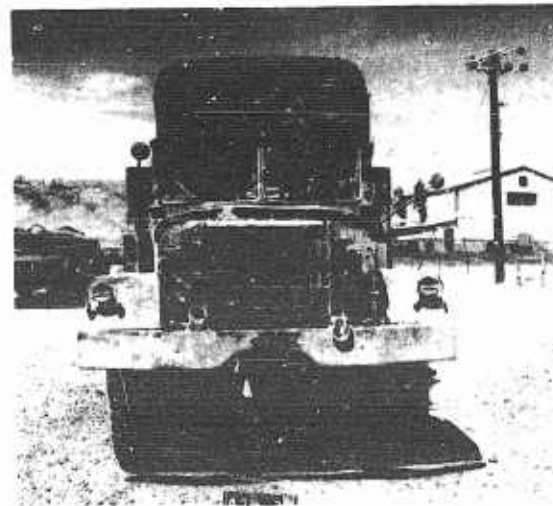
Fig. 3.133 Shot 9, Test Group 82, Shelter S-56 on Ordnance Corps 2-1/2 Ton Truck. (Top-before, Bottom left-after (Side View), Bottom right-after (Front View). Bottom Photos Taken Subsequent to Vehicle Being Moved under Its Own Power from the Test Site.) 4550 ft, 33.5 cal, 6.9 psi, 200 r at Surface.

82***	4550	33.5	6.9	200	L	S	Exposed surfaces scorched. Front blown in, top and sides crushed in beyond repair.
63	4650	32.5	6.6	160	N	S	Front blown in, top demolished, sides crushed, beyond repair.
64	5625	24	5.4	80	N	S	Front blown in, top blown in, one side crushed in, one side caved out, blown about 5 ft from original position, beyond repair.

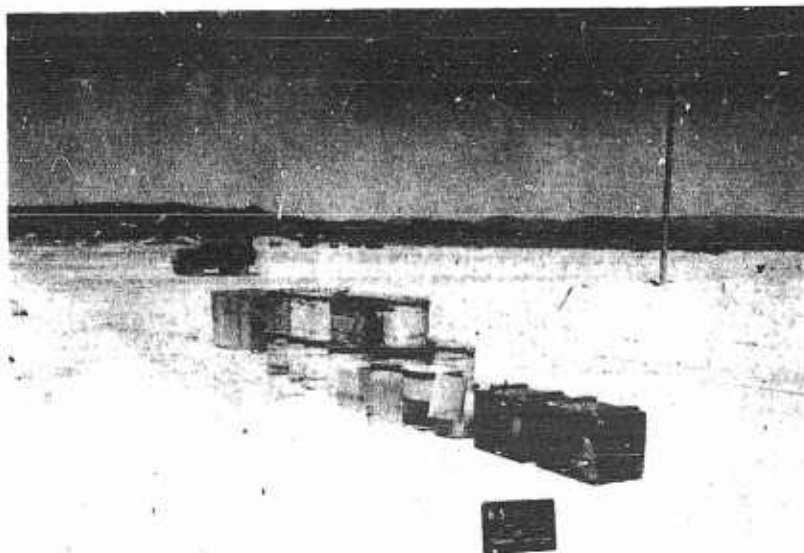
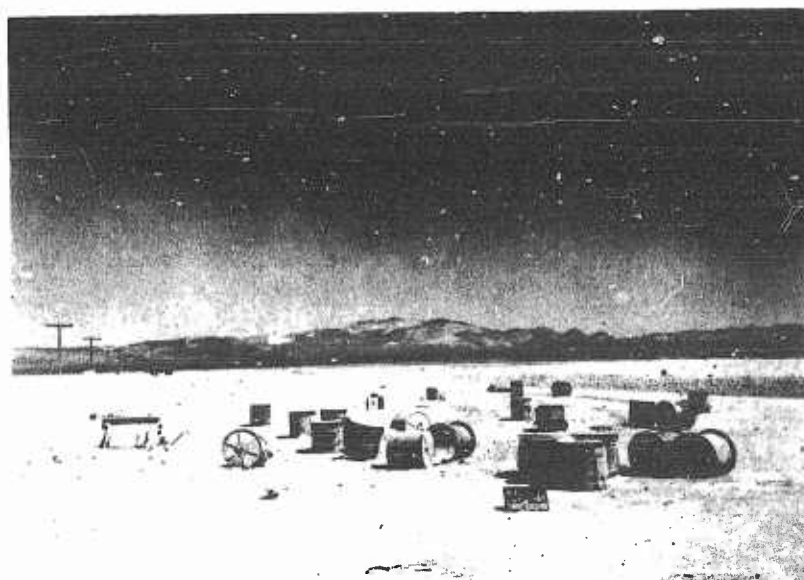
Fig. 3.134 Shot 9, Test Group 65, Signal Supply Point.
(Top-before, Bottom-after)
1900 ft, 88.5 cal, 12.8 psi, 3160 r at Surface.

Test Group No.	Ft from GZ	cal	psi	Gamma*	D A M A G E		Remarks
					Thermal	Blast	
65	1900	88.5	12.8	3160	L	L	2WD-1/TT field wire dispensers lightly scorched on GZ side. Cable reels scattered and blown from 40 to 120 ft from original position. One PE-75 packing crate broken, light damage to PE-75 power unit.
66	3150	55	10.2	1160	S	L	Several wire and cable reels caught fire and burned completely, others burned through several layers of wire on reels. One TRC-1 Transmitter burned up. Several cable reels scattered. PE-75 packing crate broken, light damage to PE-75 power unit.
102**	3150	55	10.2	1160	N	N	No thermal damage. Some of items in the pit covered with dirt, others moved about, no damage.
67	3650	46	9.0	720	N	N	No thermal damage. Reels scattered about, one PE-75 packing case broken, no damage.
68	4675	32	6.6	160	L	N	One reel W-110-B severely burned, slight scorching on other exposed items. Reels and boxes scattered to 30 ft from original positions, no damage.

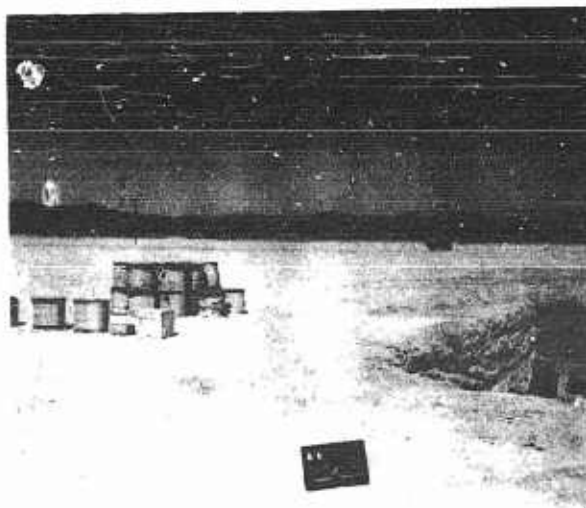
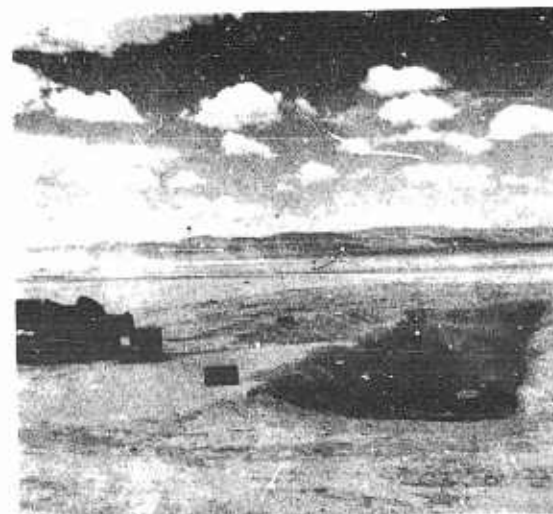
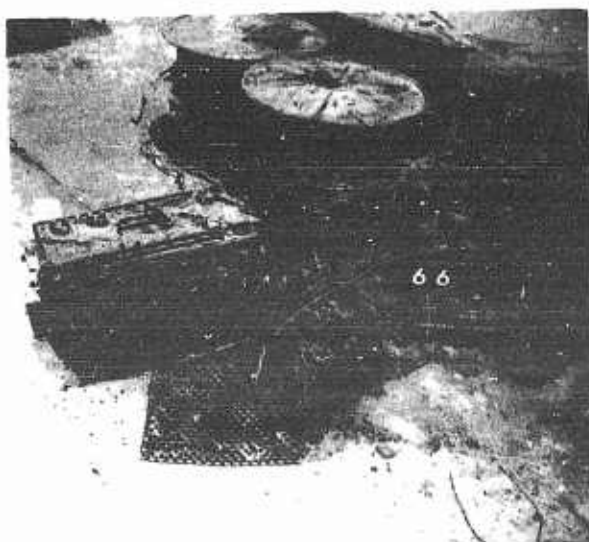
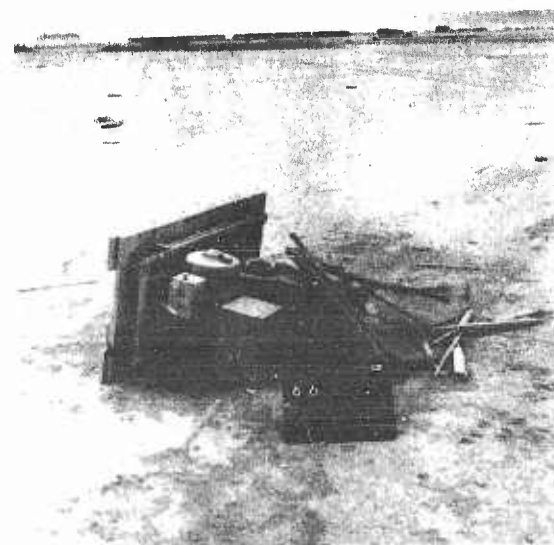
Fig. 3.135 Shot 9, Test Group 66, Signal Supply Point. (Top left-before, Top right-after, Bottom left-Close-up of AN/TRC-1 Transmitter-after, Bottom right-close-up of PE75 Power Unit-after)
NOTE: Signal Supply Point in Open Pit in Top and Center of Photos. 3150 ft, 55 cal, 10.2 psi, 1160 r at Surface.

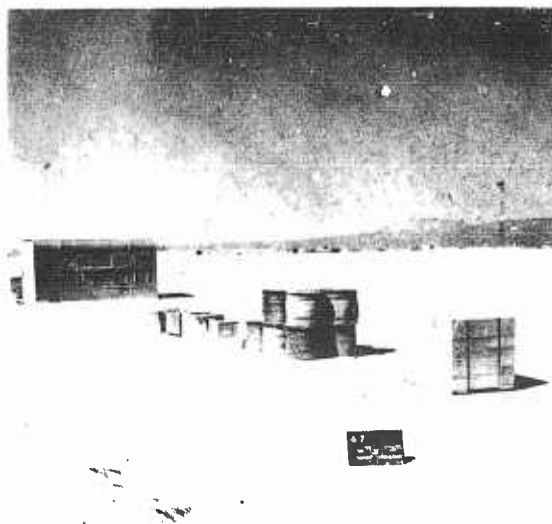
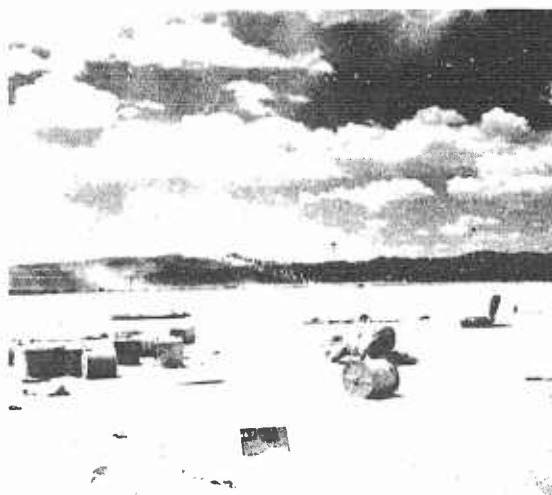
Fig. 3.136 Shot 9, Test Group 67, Signal Supply Point. (Top-before, Bottom-after). 3650 ft, 46 cal, 9.0 psi, 720 r at Surface.

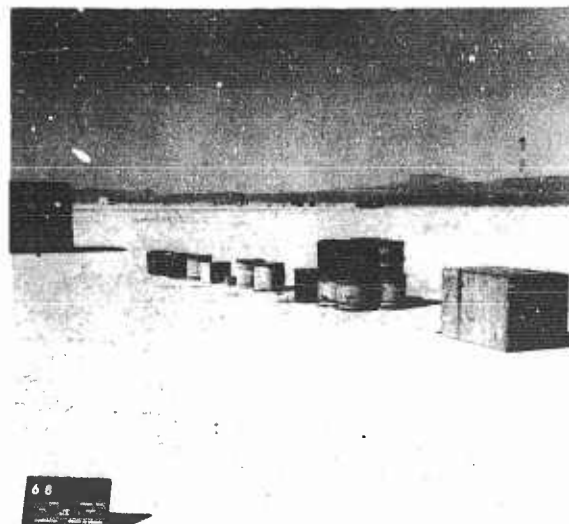
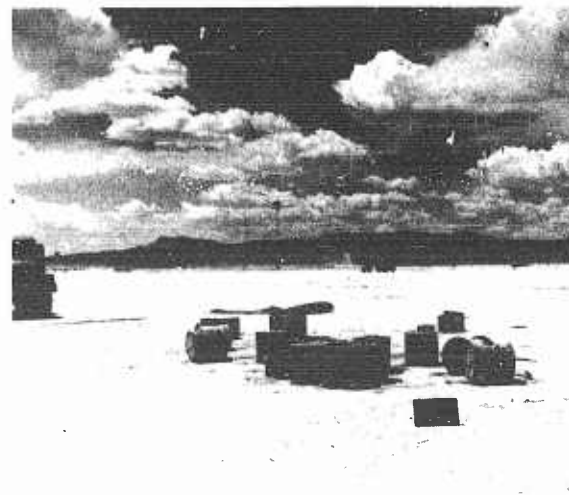
Fig. 3.137 Shot 9, Test Group 68, Signal Supply Point. (Top-before, Bottom-after) 4675 ft, 32 cal, 6.6 psi, 160 r at Surface.

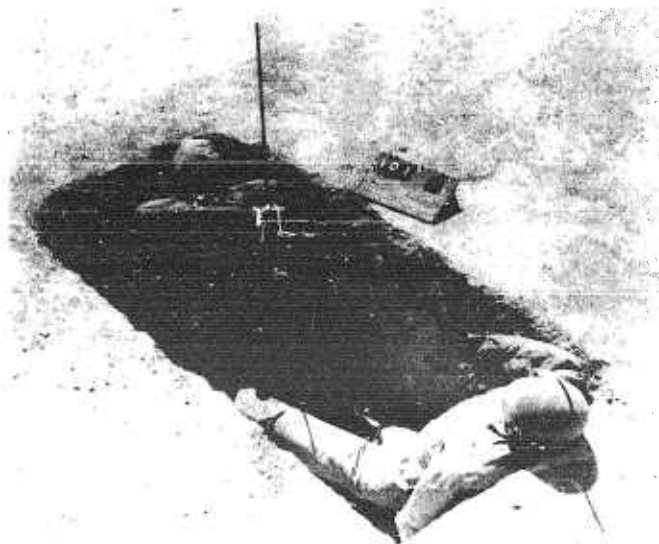
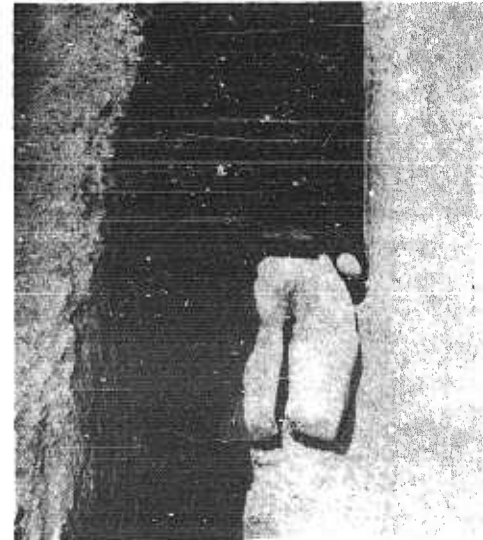
b. RESULTS: The dummies in Test Group 101, the foxhole at 1725 ft, 90 cal, 13.6 psi (Fig. 3.140), burned up. An examination of the high speed photography taken during the shot indicates that the intense heat caused both the dummies and the two radio sets (AN/PRC-6 and AN/PRC-9) to burn up almost instantaneously. The radio sets were destroyed by primary rather than by secondary effects.

Fig. 3.140 Shot 9, Test Group 101. Foxhole with Radio Sets AN/PRC-10 on Dummies. (Top-before, Bottom-after) 1725 ft, 90 cal, 13.6 psi, 3560 r at Surface.

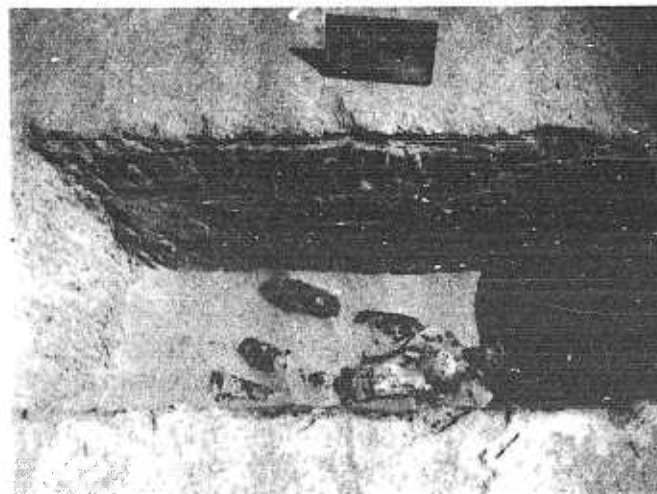
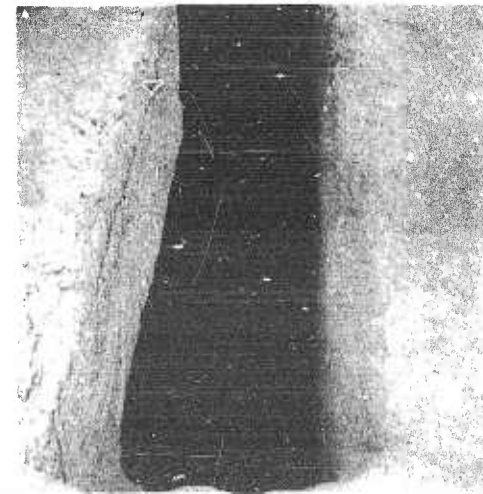
Fig. 3.141 Shot 9, Test Group 70. Foxhole with Radio Set AN/PRC-10 on Dummy. (Top-before, Bottom-after) 1775 ft, 91.5 cal, 13.4 psi, 3400 r at Surface.

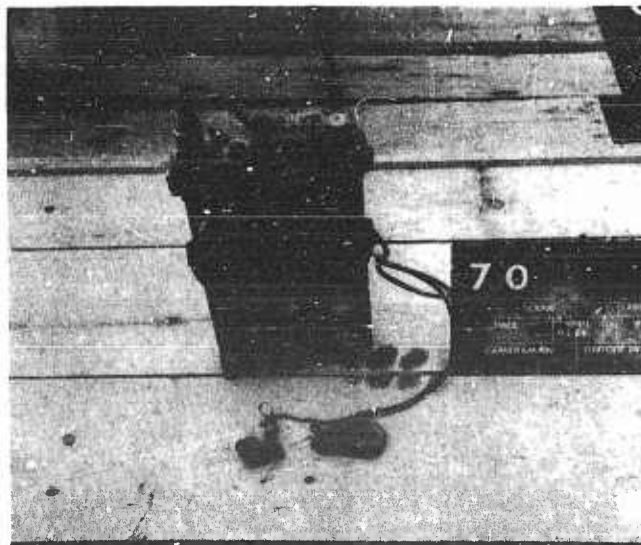
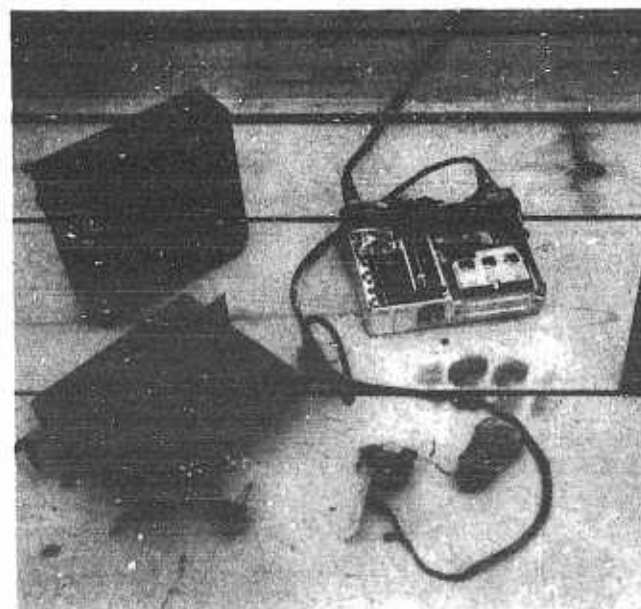
Fig. 3.142 Shot 9, Test Group 70, Radio Set AN/PRC-10 which was on Dummy in Foxhole (Fig 3.113). (Top-exterior, Bottom-Interior) 1775 ft, 91.5 cal, 13.4 psi.

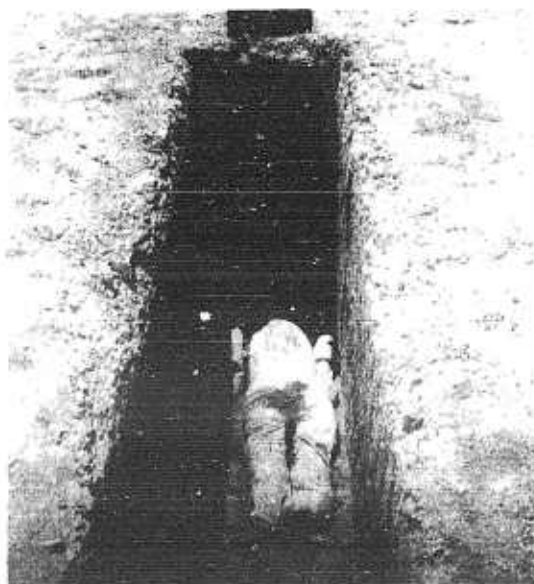
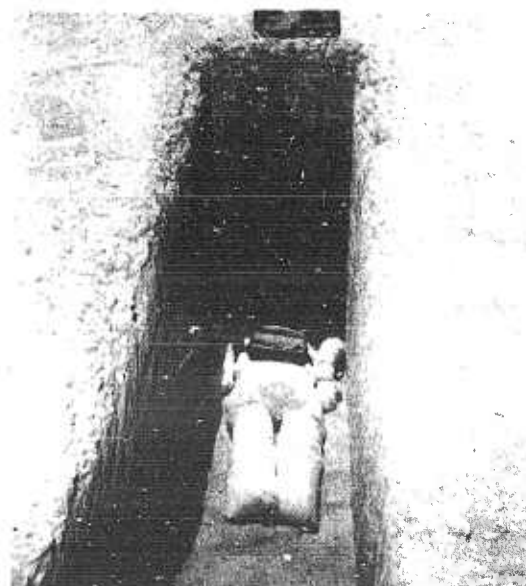
Fig. 3.143 Shot 9, Test Group 71. Foxhole with Radio Set AN/PRC-6 on Dummy. (Top-before, Bottom-after). 2800 ft, 62 cal, 10.8 psi, 1760 r at Surface.

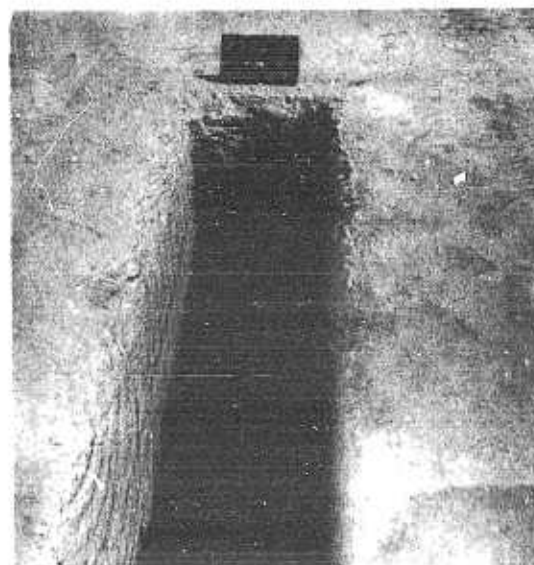
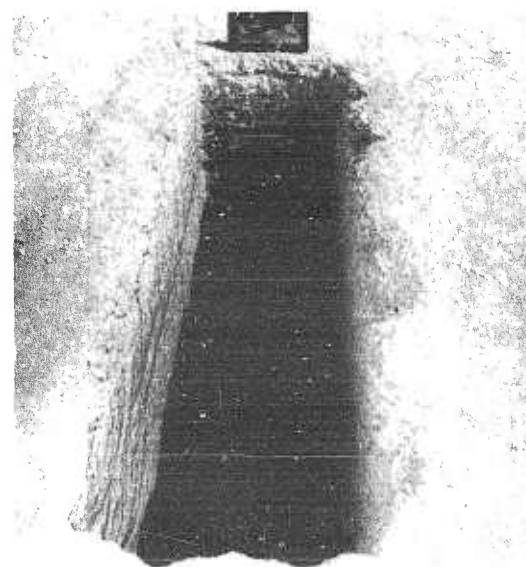
Fig. 3.144 Shot 9, Test Group 72. Foxhole with Radio Set AN/PRC-10 on dummy. (Top-before, Bottom-after). 3800 ft, 44 cal, 8.6 psi, 550 r at Surface.

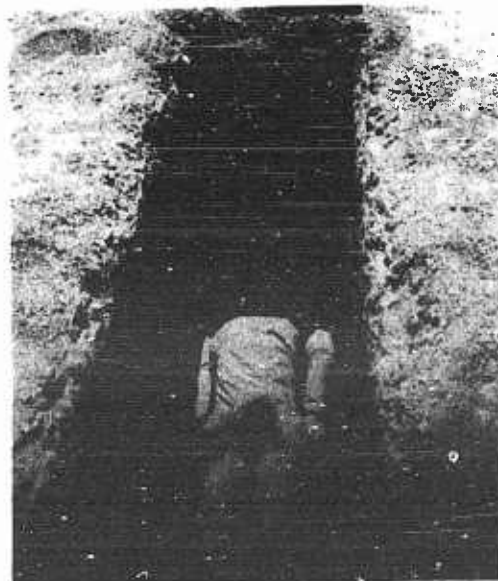
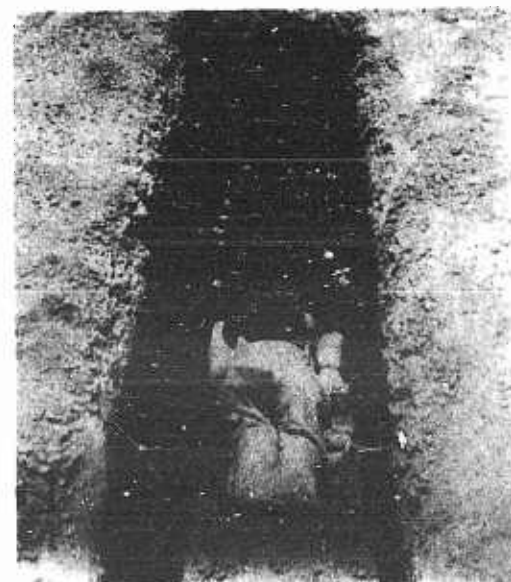
It is of interest to observe that the dummies in foxholes along the radial pole line at 3800 ft, 44 cal, 8.6 psi (Fig. 3.144), and 4800 ft, 30.5 cal, 6.4 psi (Fig. 3.145), did not catch fire and burn. However, the dummy in the foxhole at 5800 ft, 28.5 cal, 5.2 psi (Fig. 3.146), did catch fire and burn. There is no explanation for this phenomenon except that in previous tests the thermal flux has caused no damage at a given ground range from GZ which "skipped" and has caused severe damage beyond the point where no damage occurred. One can also postulate that shielding conditions or the burning point of the materials in this particular dummy (fabric and straw) were such that burned.

Fig. 3.145 Shot 9, Test Group 73.
Foxhole with Radio Set AN/PRC-6 on
Dummy and EE-8 Telephone in Foxhole.
(Top-before, Bottom-after) Dummy
was Moved to Sitting Position from
Prone Prior to Test. 4800 ft, 30.5
cal, 6.4 psi, 160 r at Surface.

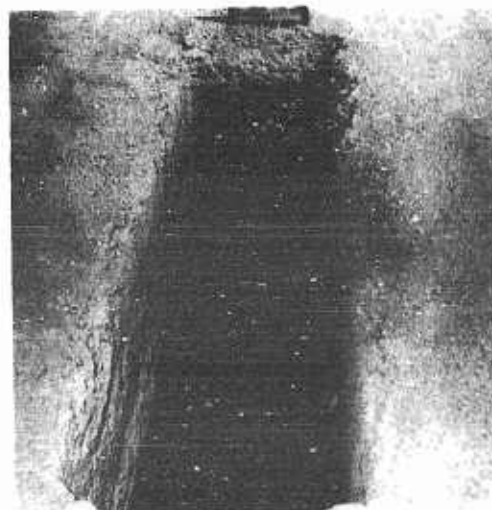
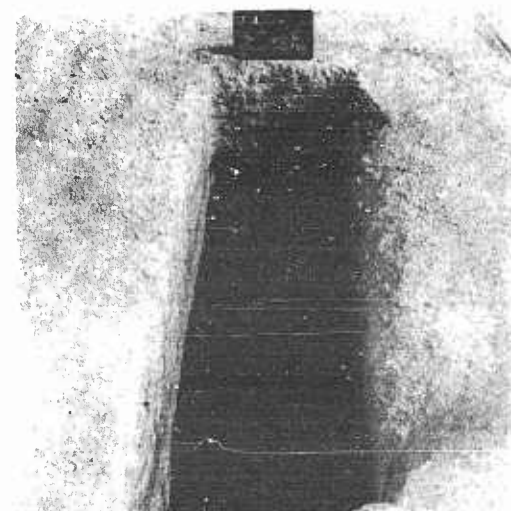
Fig. 3.146 Shot 9, Test Group 74.
Foxhole with Radio Set AN/PRC-10 and
Dummy and EE-8 Telephone in Foxhole.
(Top-before, Bottom-after) 5800 ft,
28.5 cal, 5.2 psi, 80 r at Surface.

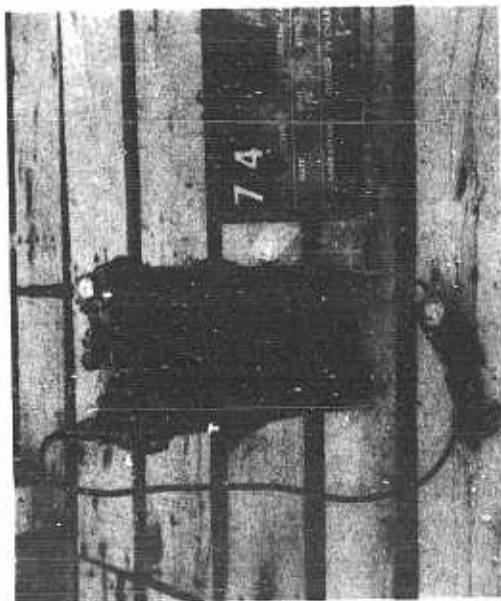
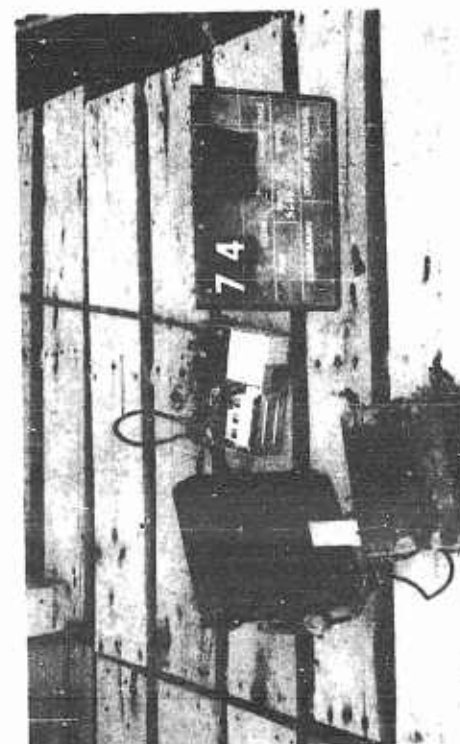
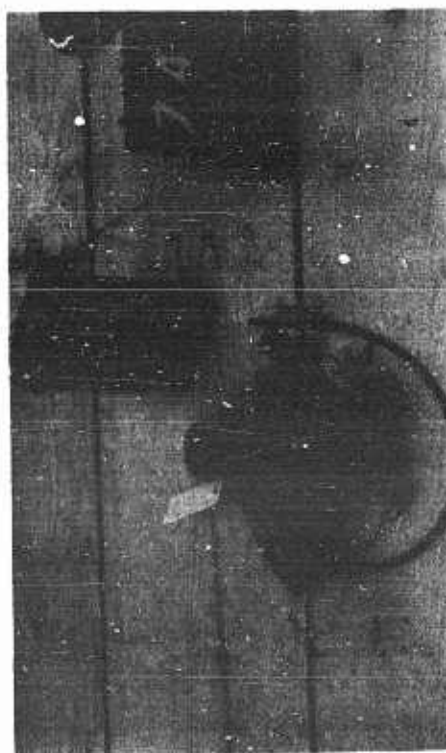
Fig. 3.147 Shot 9, Test Group 74, Radio Set AN/PRC-10 and Telephone Which were in Foxhole (Fig. 3.118).
(Top-exterior, left-interior, Right-EE-8 Telephone)
5800 ft, 28.5 cal, 5.2 psi.

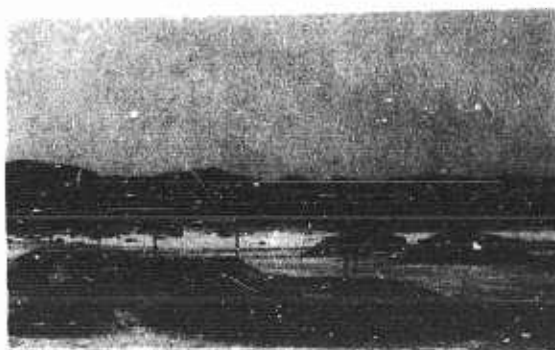
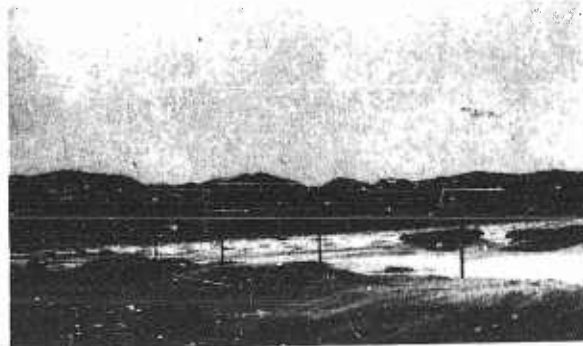
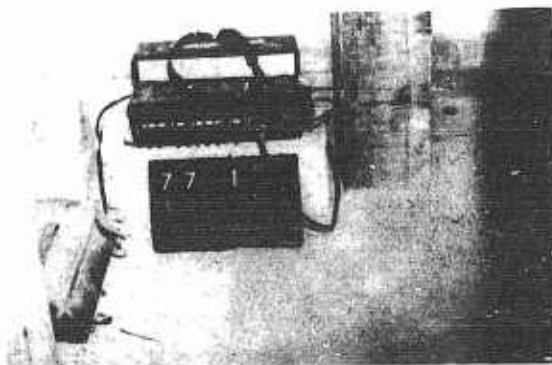
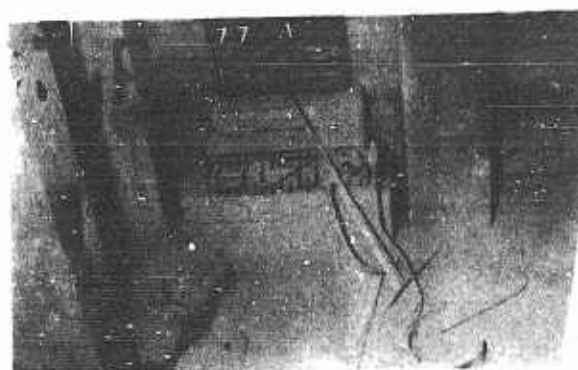
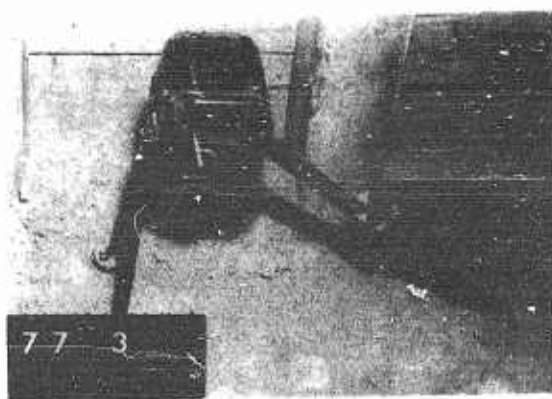
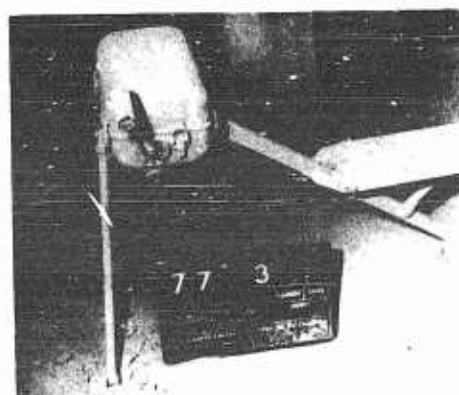
Fig. 3.150 Shot 9, Test Group 77, Signal Corps Items in Corps of Engrs. Installations (CO Type CP). (Top left-before, Top right-after; SB-22 Switchboard, Center left-before, Center right-after; GN-58A Generator, Bottom left-before, Bottom right-after.) 500 ft, over 125 cal, over 21 psi, 6400 r at Surface.

Test Group No.	Ft from GZ	cal	psi	Surface Gamma*	D A M A G E		Remarks
					Thermal	Blast	
77	600	over 125	over 21	6400	N	N	CP shielded from thermal damage. Dust permeated the CP and the equipment, equipment operable.
78	900	over 125	over 21	5400	N	N	CP shielded from thermal damage. Dust permeated CP and the equipment, operable.
79	4000	41	8	400	N	N	CP shielded from thermal damage. Dust permeated CP and the equipment, equipment operable.

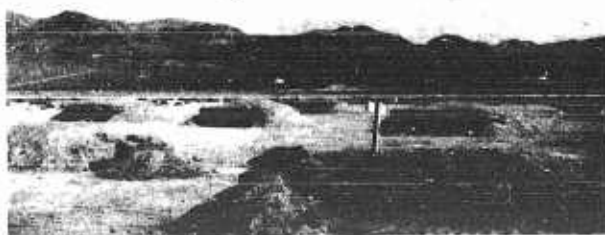
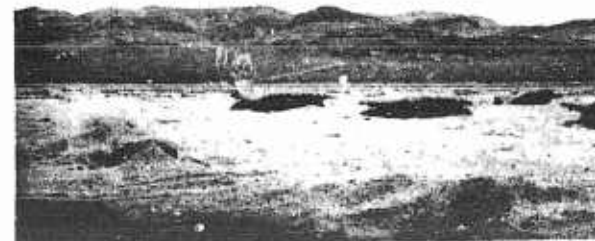
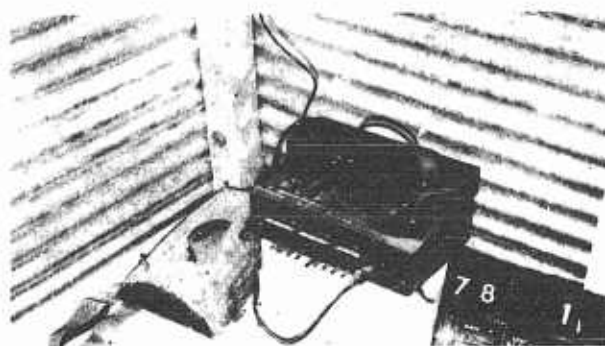
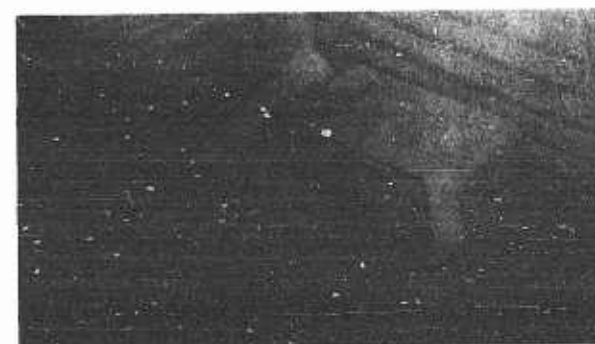
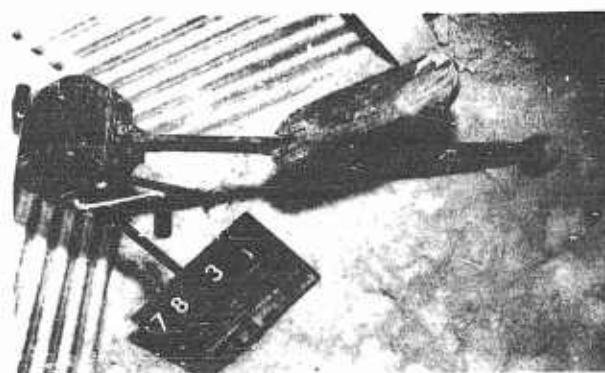
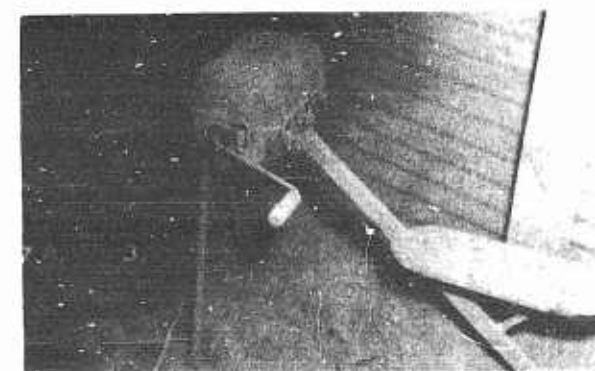
Fig. 3.151 Shot 9, Test Group 78, Signal Corps Items in Corps of Engrs. Installations (CO Type CP). (Top left-before, Top right-after; SB-22 Switchboard, Center left-before, Center right-after; GN-58A Generator, Bottom left-before, Bottom right-after.) 900 ft, over 125 cal, over 21 psi, 5400 r at Surface.

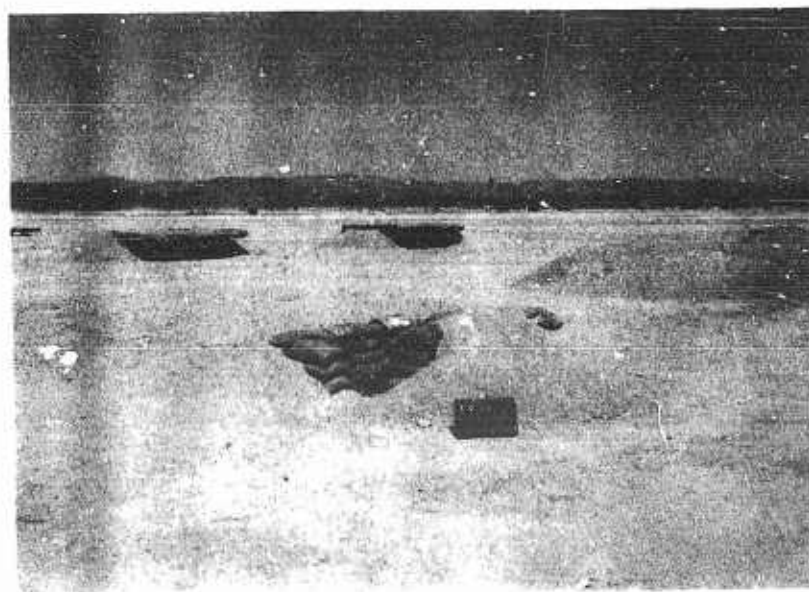
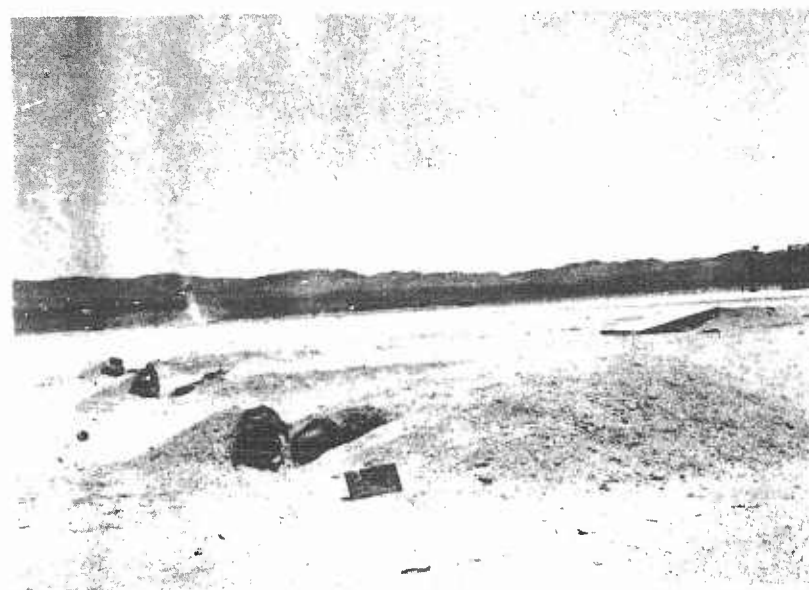
Fig. 3.152 Shot 9, Test Group 79, Signal Corps Items in Corps of Engrs. Installation (CO Type CP). (Top-before, Bottom-after) (See Fig. 3.153 for Equipment.) 4000 ft, 41 cal, 8 psi, 400 r at Surface.

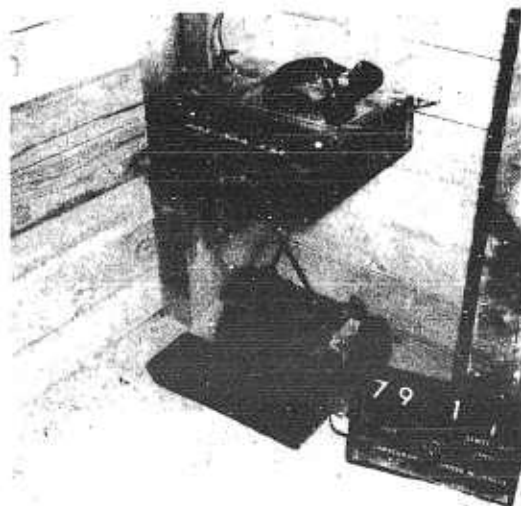
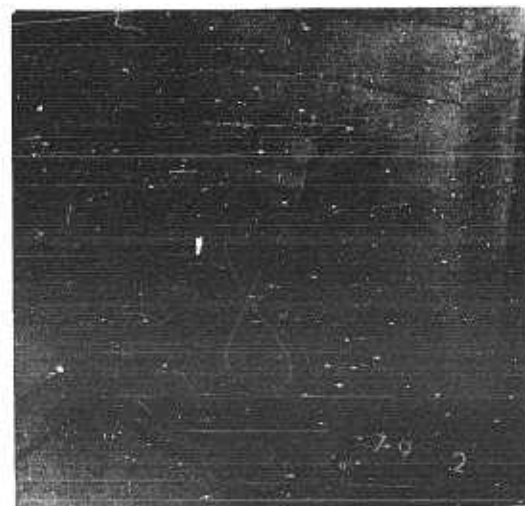
Fig. 3.153 Shot 9, Test Group 79, Signal Corps Items in Corps of Engrs. Installations (CO Type CP-Fig. 3.124). SB-22 Switchboard (Top left-before, Top right-after; GN-94 Generator and EE-8 Telephone (Bottom left-before, Bottom right-after) 4000 ft, 41 cal, 8 psi, 400 r at Surface.

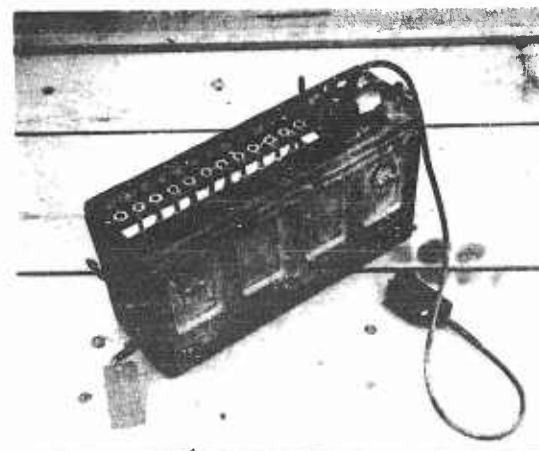
b. RESULTS: The field hospital above and below the surface at 4125 ft, 39.5 cal, 8 psi (Fig. 3.154) caught fire and burned up. An examination of high speed photograph taken during the shot indicates that the heat caused the tent to burn from primary effects. It is extremely doubtful if the telephone equipment in the tent was damaged from primary effects. It is more plausible to believe that the heat from the tent burning caused secondary damage to the telephone equipment. The entire burning cycle is very, very rapid. A damage summary for this test group is shown in Table 3.22.

Fig. 3.154 Shot 9, Test Group 83, Signal Corps Items in Medical Corps Installations. (Field Hospital in Tents at the Surface.) (Top left-before, Bottom left-after; Top right, SB-22 Switchboard-after, Bottom right, close-up of Same Switchboard-after) 4125 ft, 39.5 cal, 8 psi, 320 r at Surface.

Test Item	Ft from GZ	cal	psi	Surface Gamma*	D A M A G E		Remarks
					Thermal	Blast	
IN TENT BELOW THE SURFACE							
SB-22 Switchboard	4125	39.5	8	320	S		Plug melted on bakelite strip, transmitter cord burned up, drop indicators melted. Switchboard thrown to ground.
TP-6 Telephone	4125	39.5	8	320	S	L	Handset, cord, induction coil and condenser completely burned. Telephone thrown to ground.
EE-8 Field Telephone	4125	39.5	8	320	S	L	Handset cord severely burned, terminals button and WD-1/TT wire melted. Telephone thrown to ground.
IN TENT ABOVE THE SURFACE							
SB-22 Switchboard	4125	39.5	8	320	L	L	Spare telephone line circuit severely burned, spare parts kit slightly burned. Thrown 300 ft from original position, one plug slightly damaged battery case out of sockets. Case slightly damaged near ring back key. Serviceable after minor repairs made.
TP-6 Telephone	4125	39.5	8	320	L	L	Slight
EE-8 Field Telephone	4125	39.5	8	320	L	L	Slight

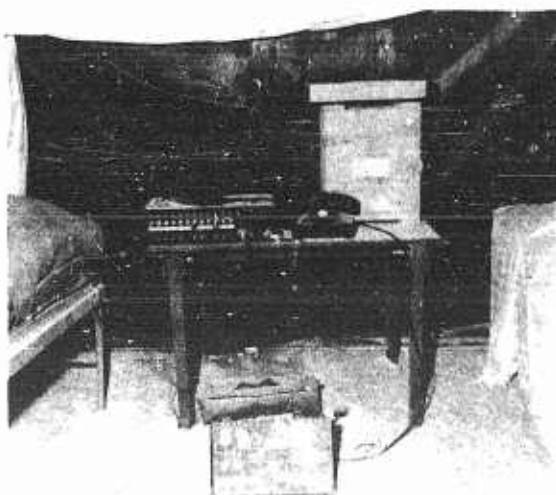
Fig. 3.155 Shot 9, Test Group 83, Signal Corps Items in Medical Corps Installations. (Field Hospital in Tents Revetted below the Surface.) (Top left-before, Top right-after, Bottom, SB-22 Switchboard-after) 4125 ft, 39.5 cal, 8 psi, 320 r at Surface.

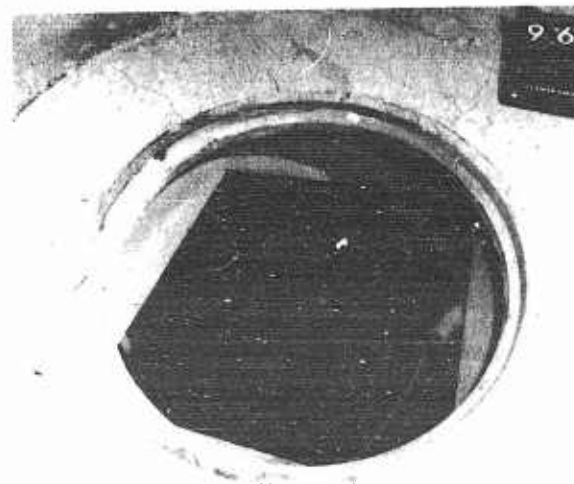
b. RESULTS: The manhole cover in Shot 9 (1250 ft, 113 cal, 16.6 psi), was lifted from its base and moved 1/2 in. There were several

inches of dirt blown into the manhole but there was no apparent damage to the cable transfer relay or cable installed in manhole.

In Shot 10 the manhole cover (600 ft, over 65 cal, over 115 psi), was forced into the manhole and covered with 1-1/2 ft of earth. The manhole (field constructed) was crushed in and filled with 1-1/2 ft

Fig. 3.156 Shots 9 and 10, Test Group 96, Manhole. (Top left-before 9, Bottom left-after 9; Interior of Manhole, Top right-before 9, Bottom right-after 9.) NOTE: The Manhole was destroyed in Shot 10. Shot 9 - 1250 ft, 113 cal, 16.6 psi. Shot 10 - 600 ft, over 65 cal, over 115 psi.

of earth. The concrete tile was intact. There was no cable transfer relay present in the manhole for Shot 10. The cable in the manhole was not damaged.
